AIRCRAFT ACCIDENT  
IDENTIFICATION  
NO.

710 05 101

## NAVAVNSAFECEN MISHAP CODE SHEET

4 MAR 1968

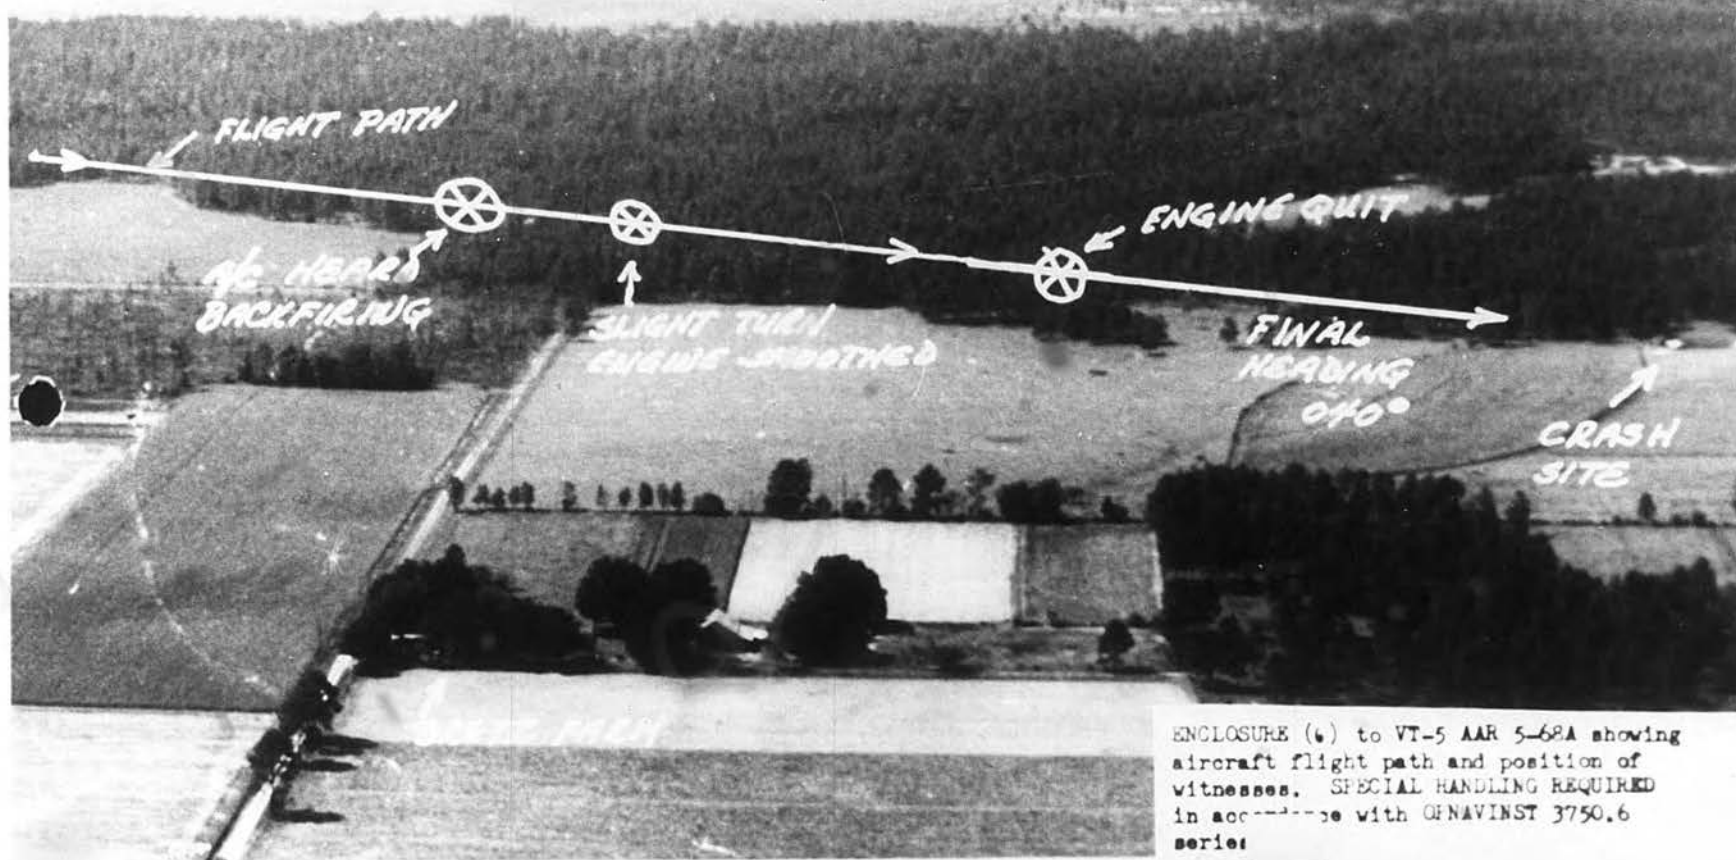
ENCLOSURE (6) to VT-5 AAR 5-68A showing aircraft flight path and position of witnesses. SPECIAL HANDLING REQUIRED in accordance with OPNAVINST 3750.6 series
